FIELD INSPECTION REPORT

63 DOWNING STREET

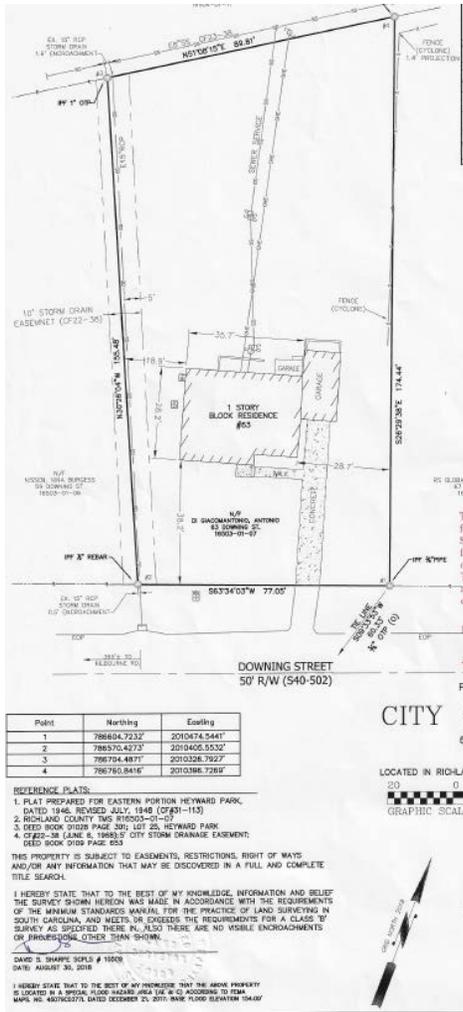
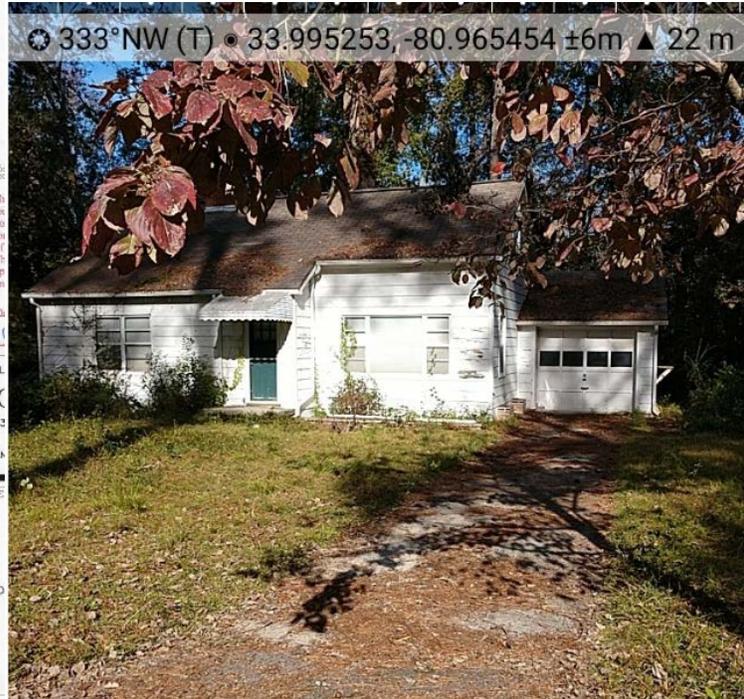
Figure 1 63 Downing Street

Trees – 1 A small Dogwood is adjacent to the driveway and overhangs the driveway. A determination on the removal of the trees can be made during construction and is minimal cost for removal.

Other large tree are present in the front and back yard but do not hinder the demolition effort.

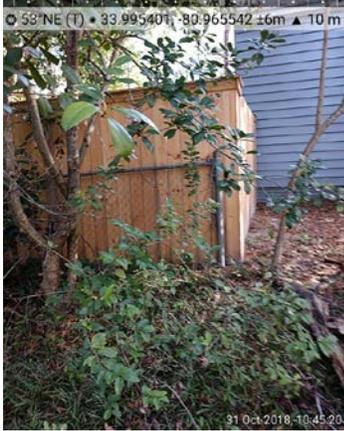
Figure 2 - East Property Fencing

Boundaries - The eastern property line has a 4-foot chain link fence that appears to be on the adjacent property. There were no stakes to determine actual boundaries at the property.

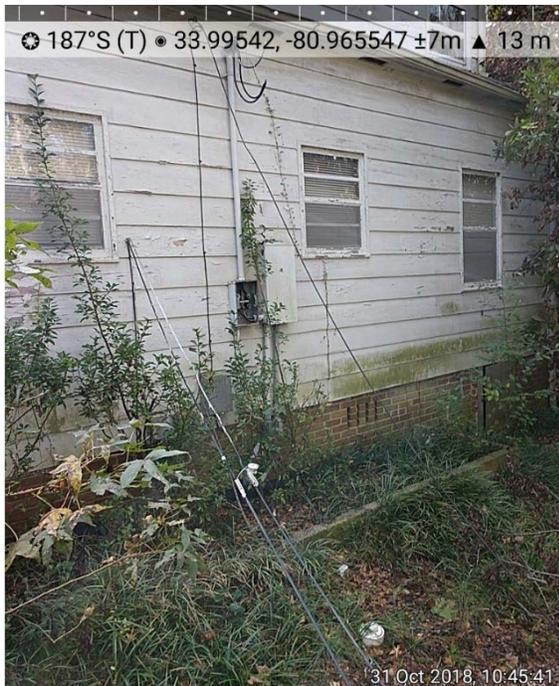
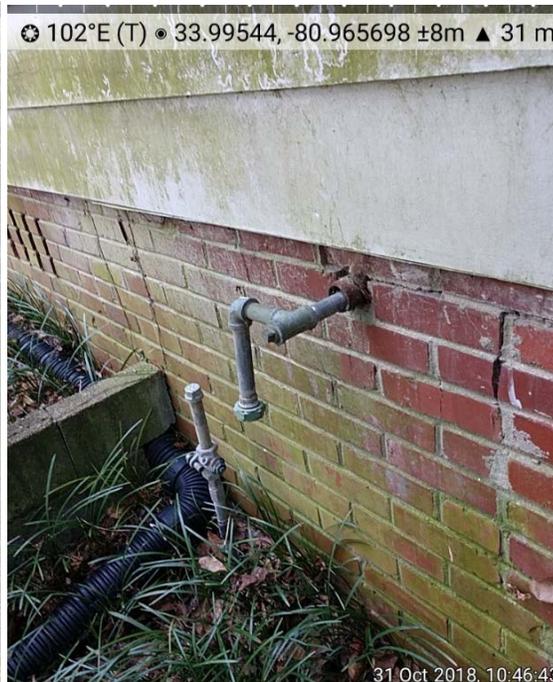
Figure 3 Utility Status and Position Photographs

Drainage - Removal of the structure will require grading to minimize erosion concerns.

Sewer - The survey did not identify the sewer cleanout on the south side of house. City Sewer or septic was not determined.

Power - The power is disconnected from the house and meter removed

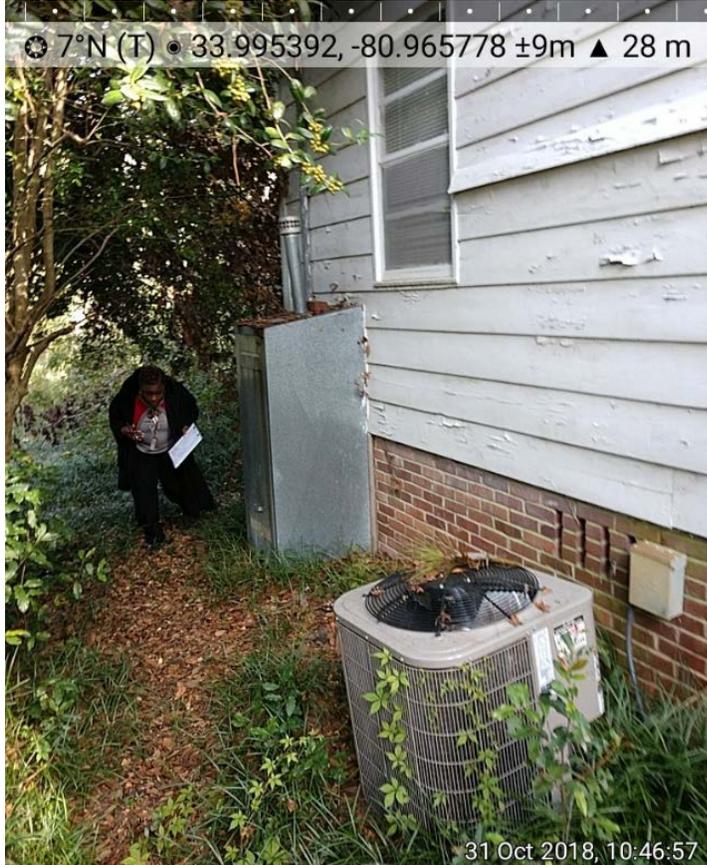
Figure 4 - HVAC and HWH West Side of House

HVAC - Ac only

Hot Water Heater - Located outside on west side of house.

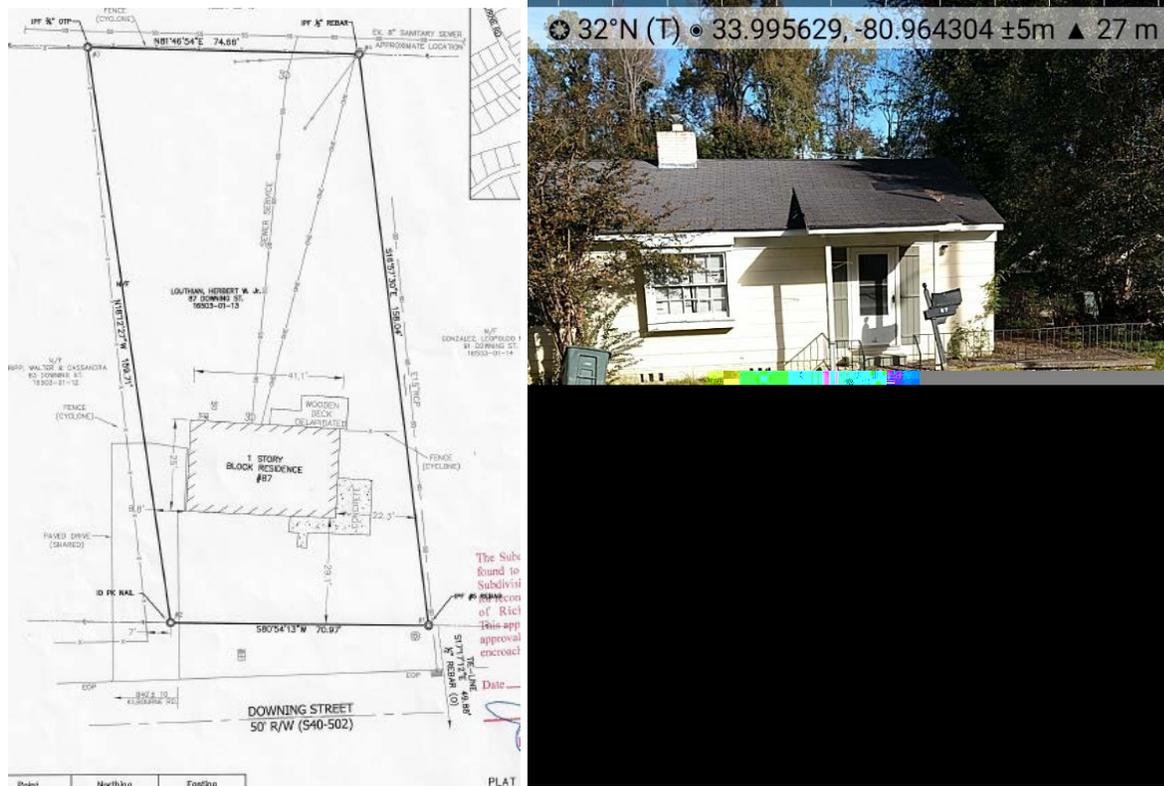
Figure 1 87 Downing Street

Trees 1– A large Pine has fallen in the backyard a dislocated the rear deck from the house

Tree 2 - A large pine that has been topped and limbed is adjacent to the driveway

Driveway - The asphalt driveway is shared by the adjacent property to the west and has a 4-foot chain link fence that is not on the property.

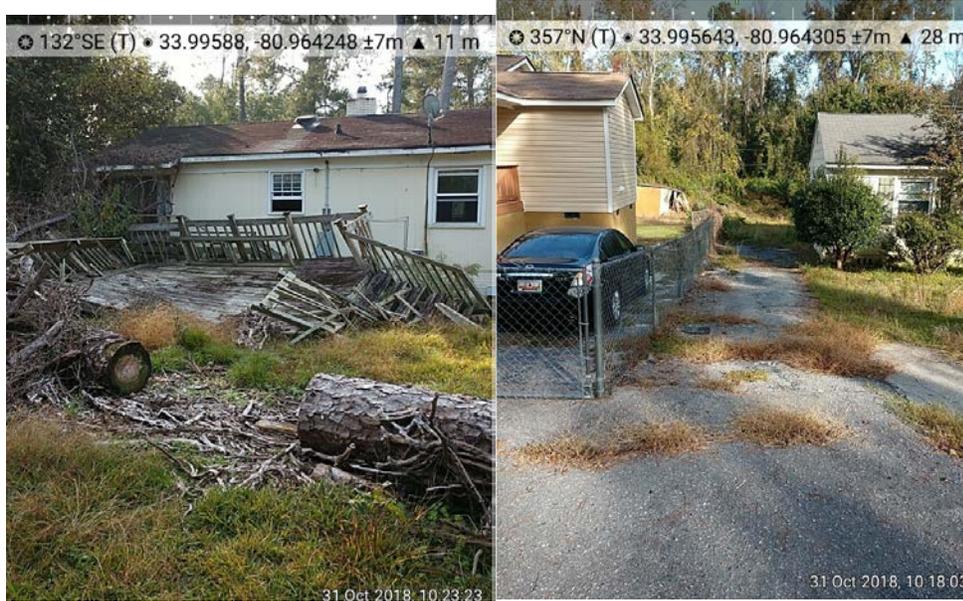
Figure 2 -Rear Deck damaged by Pine Tree and Shared Driveway

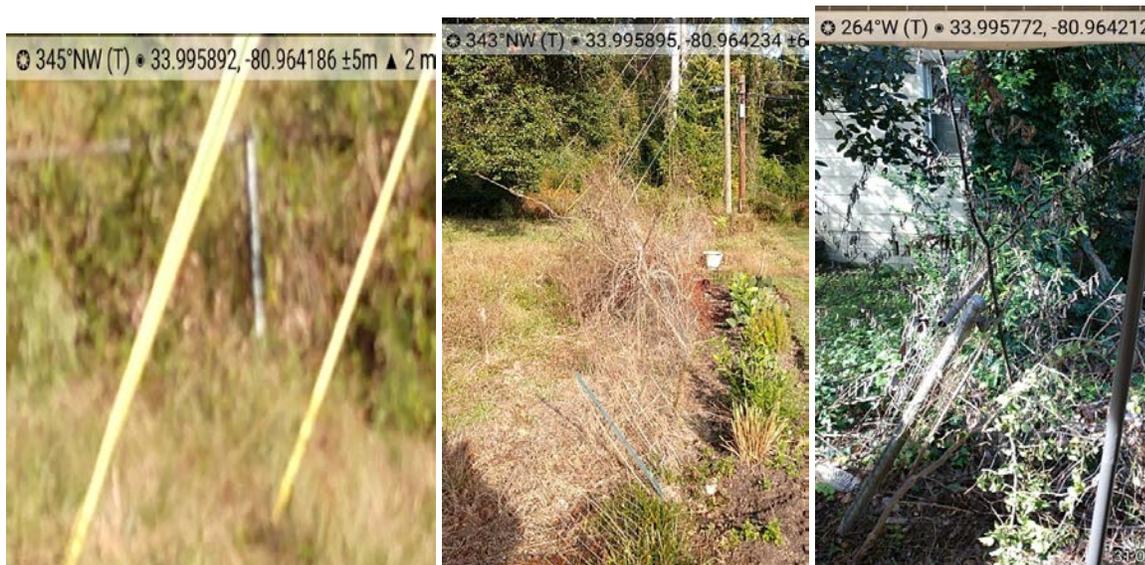
Figure 3 - Fencing on Property Boundaries

Boundaries - There is fencing behind the house. The western property line has a 4-foot chain link fence that appears to be on the adjacent property and continues to the northern boundary fence which is 4-foot chain link. The eastern boundary has a 3-foot rabbit wire fence that extends from the north boundary chain link fence up to a 4-foot rabbit wire fence bisecting the east flank of the house. There were no stakes to determine actual boundaries at the property.

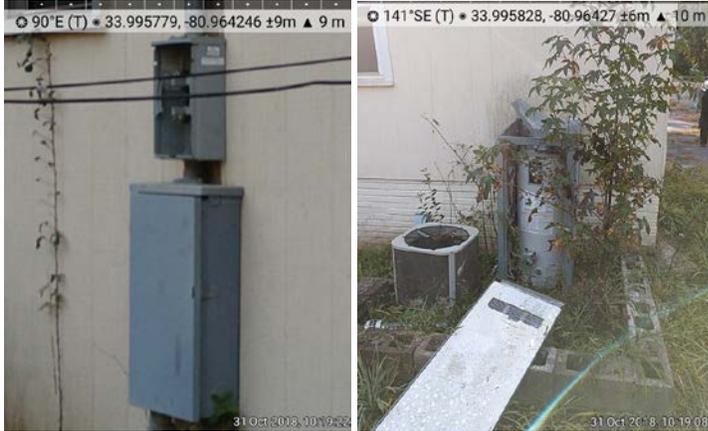
Figure 3 Utility Status and Position Photographs

Drainage - Removal of the structure will require grading to minimize erosion concerns.

Sewer - The survey did not identify the sewer cleanout on the south side of house. City Sewer or septic was not determined.

Power - The power is disconnected from the house and meter removed

Water - City water meter located on the front of the property and was marked on the survey.

Gas - Disconnect and meter removed. HTH located outside the house.

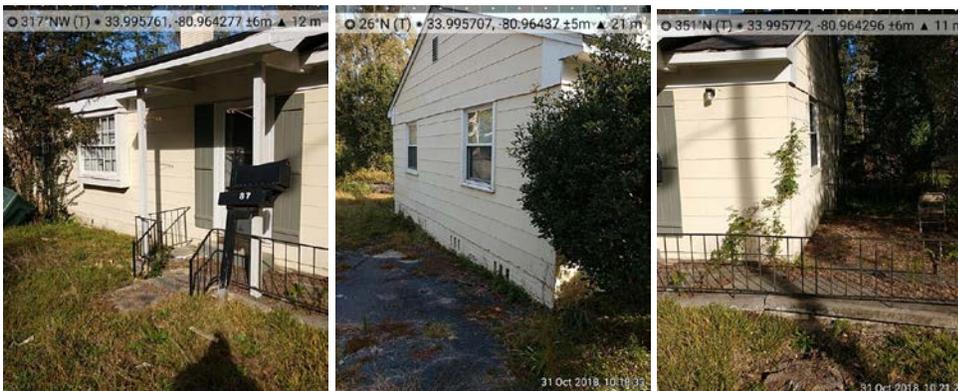
Figure 4 - Transite Siding

Environmental - The house has potential Transite siding on the front and both sides of the house. The rear appears to have already been removed

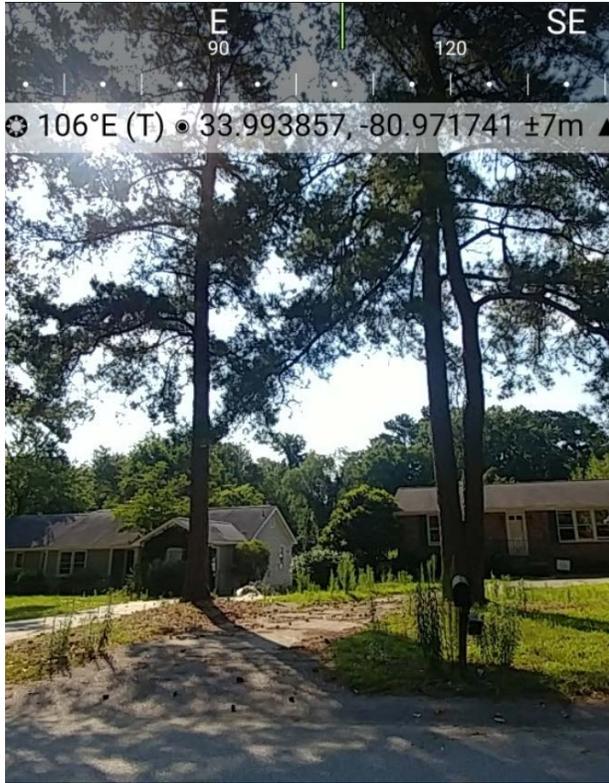
Figure 2 Pine Trees 1 , 2 & 3

Trees – 1 & 2 (below)– Pines (20 to 24-inch dia.) that are located at the entrance of the driveway. Tree 1 is located on the north side of the driveway and 2 is on the south side. The concrete driveway can remain until the house is demolished and followed by removal of the concrete driveway in section without damage to the tree root system.

Tree -3 - Laurel or Magnolia located at the NE corner of the house. It can be removed with the shrubs surrounding the house. Tree 3 is in background of Figure-2, corner of house.

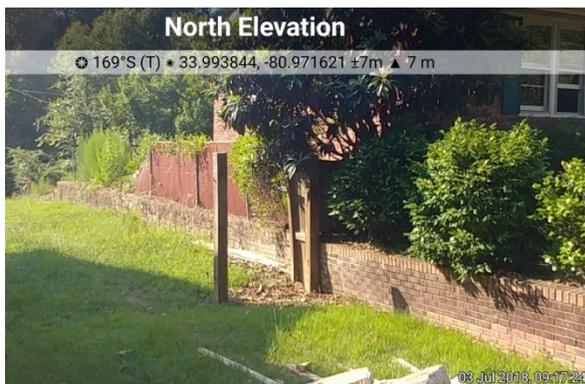
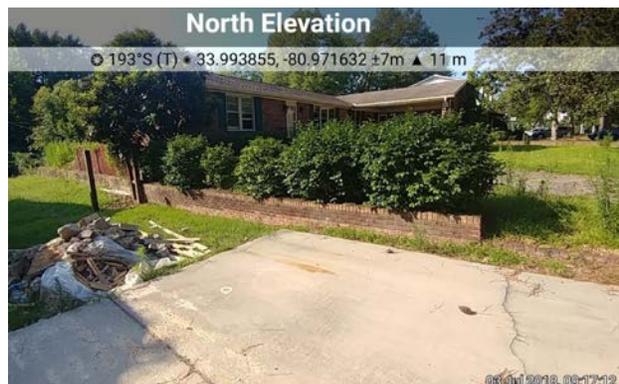
Figure 3 Northern Barrier Wall

Barrier 1 – Along the northern property line, there is a brick retaining wall approximately 3 feet high. The wall starts 30 to 40 feet south of the street and continues SE almost to the back boundary. The wall retains about 3 feet of soil until you are south of the house. The wall has 5 (3 to 4-inch) poly drains discharging rain from the gutters onto the adjacent property. The removal of the house will require material grading to re-establish grade. The fill material, behind the retaining, can be used as fill, once house is removed, and remove the drainage gradient issue on the north side of the house.

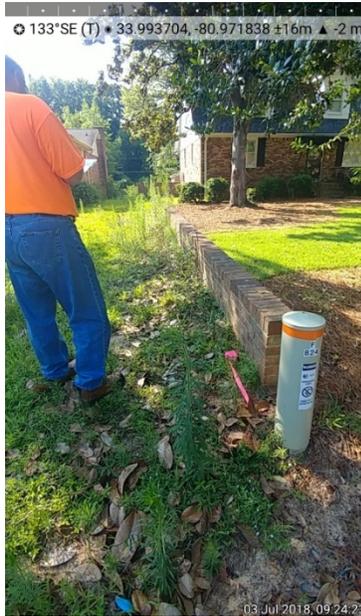
Figure 4 Southern Barrier Wall

Barrier 2 – Along the southern boundary the 2-foot brick wall is on the adjacent property and will not need to be removed. There is a wall perpendicular located on the south side that is midway the house and is part of a gate system. The wall will need to be cut to remove the barrier at the property line.

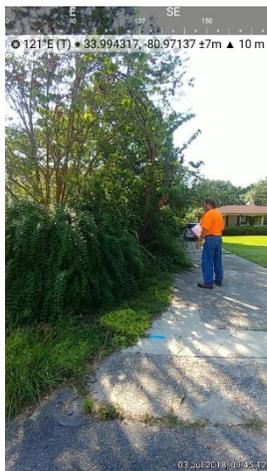
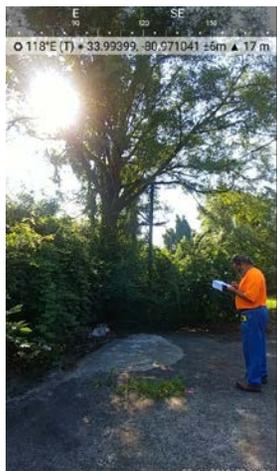
Trees – 1 Red Bud located at the north side of the entrance to the property as part of shrub line. A determination on the removal of the trees and shrub line was not possible because there were no mid-point stakes identifying property lines.

Tree -2 – Water Oak- NE corner of the driveway. On adjacent property by best judgement.

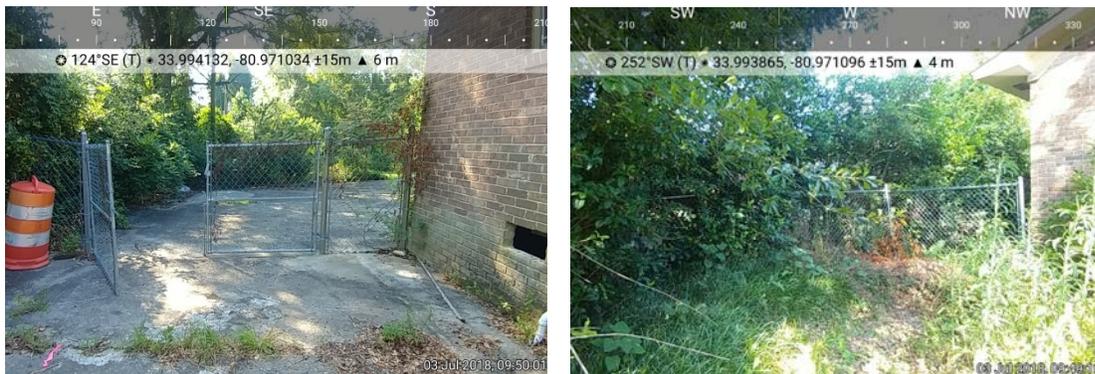
Figure 2 Fence and Pin 29 and SE corner of house

Fencing- 4-foot chain link fence surrounds the back yard. The creek front portion will need to be removed and a determination will have to be made for the north and south fences. A survey pin was placed in the driveway and was marked as “Pin 29” on the attached ribbon and does not look like boundary marker.

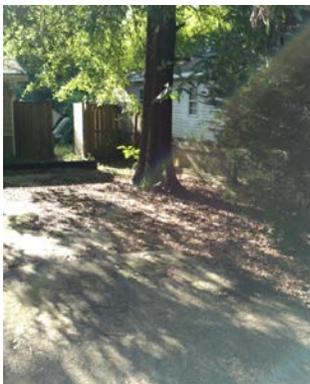
Figure 2 - Oak Tree Adjacent to Driveway

Trees – Oak tree identified at the corner of the driveway and adjacent retaining wall could be affected by the removal of the driveway (Figure 2). The tree needs to be evaluated.

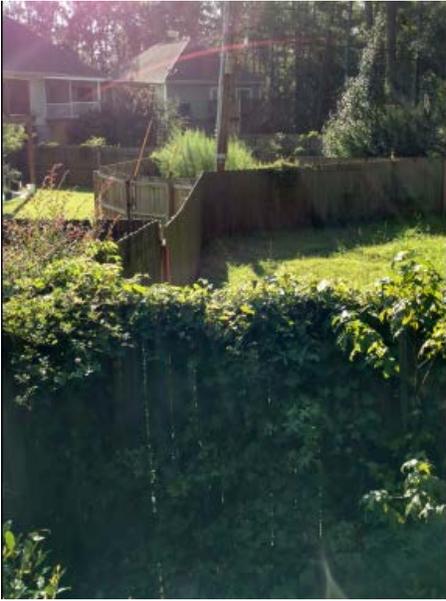
Figure 3 - Potential Encroachment N and E Boundaries

Fencing - The backyard of the property has 6-foot wood privacy fencing. The north and east fence sections are ajoined by adjacent property fences. The NE corner connections have encroached on the property and notification to the adjacent property owners will need to be determined. The fence on the south side is not on the property (Figure 3).

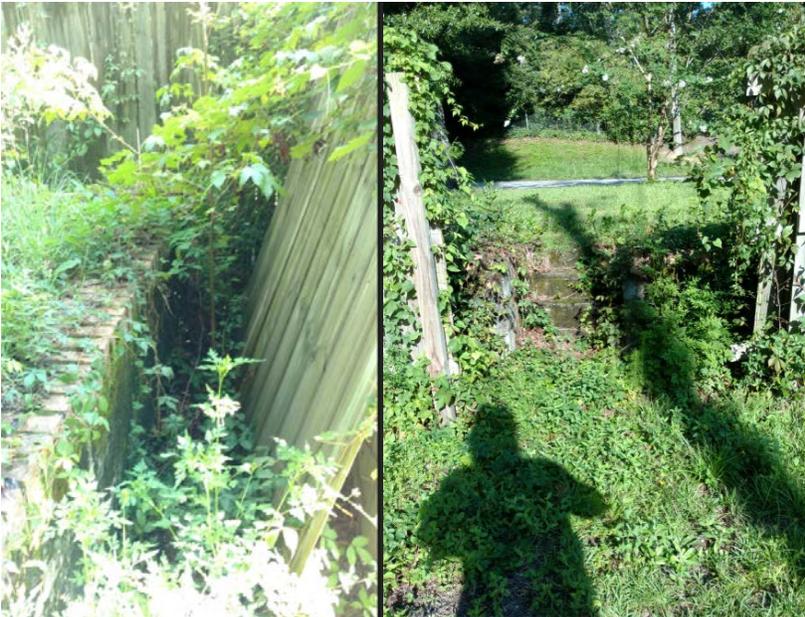
Figure 4- Retaining Wall Along N Boundary

Drainage - The structure is split level and the north end of the house has a 3-foot retaining wall that attaches to the NW corner of the house and extends to the North boundary and turn west towards the road. Removal of the structure will require grading to minimize erosion concerns (Figure 4).

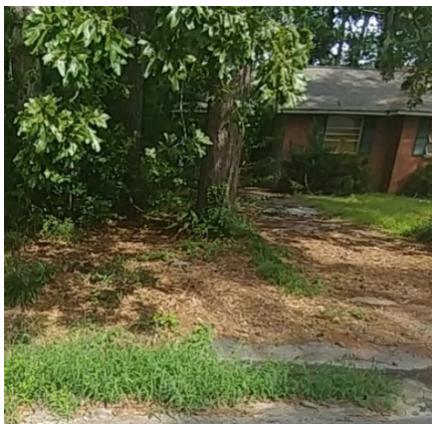
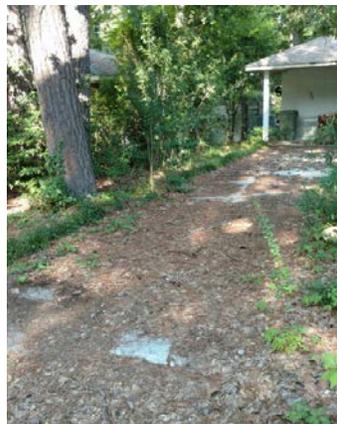
Figure 2 - Pine tree at NE Corner of Property

Tree 1 - Large Pine (20 to 24 inch) located at the NE corner of the property has buckled the driveway. Removal of the structure may cause potential issues with the roots under the driveway (Figure 2).

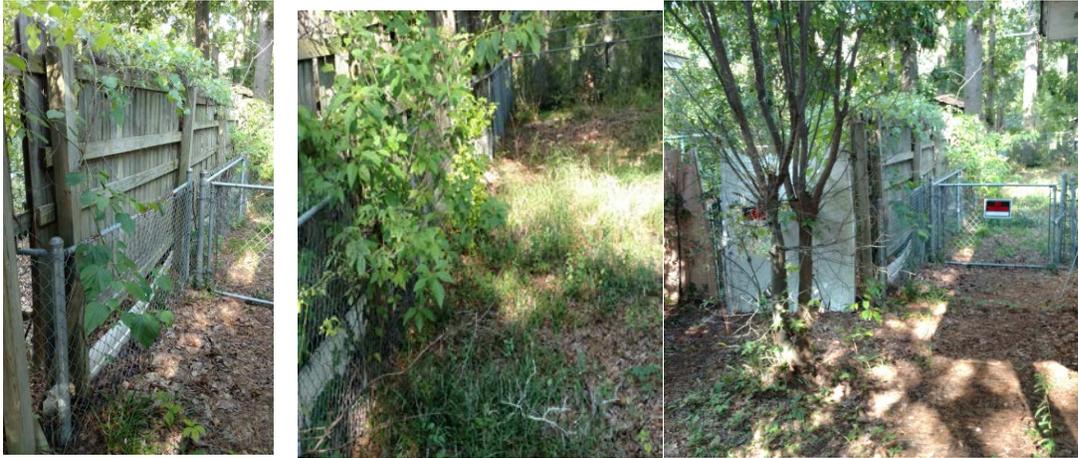
Figure 3 Fencing Issues NE Corner of House

Fencing - The backyard of the property has 4-foot chain link fencing. The north, south, and east fence sections are ajoined by adjacent property fences. The chain link fence appears to be on the property. The 6-foot wood fence on the north boundary is in question (Figure 3). The properties will require some detemination and may require notification to the adjacent property owners.
