FIELD INSPECTION REPORT

63 DOWNING STREET

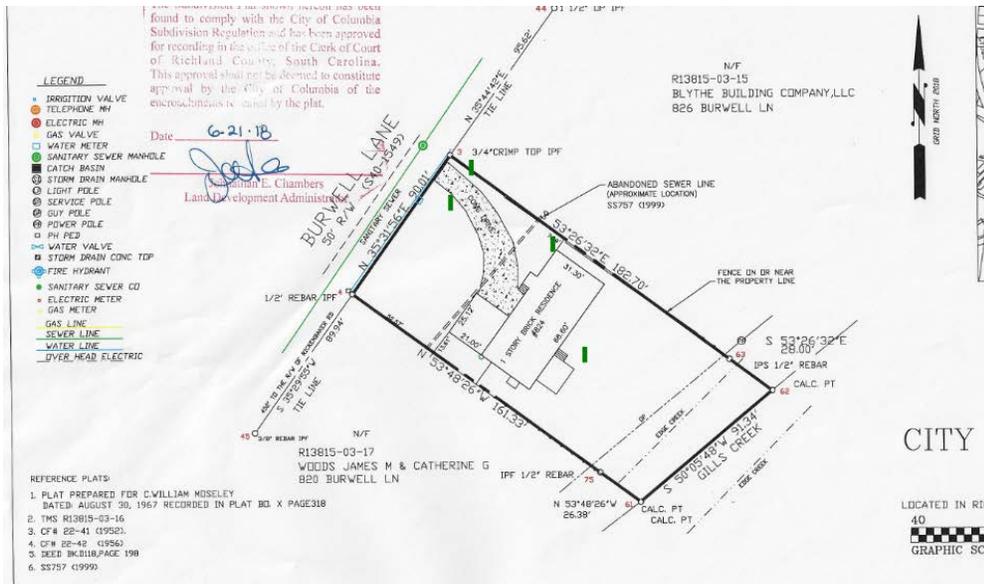
Figure 1 824 Burwell Lane

Trees – 1 & 2 (below)– Pines (20 to 24-inch dia.) that are located at the entrance of the driveway. Tree 1 is located on the north side of the driveway and 2 is on the south side. The concrete driveway can remain until the house is demolished and followed by removal of the concrete driveway in section without damage to the tree root system.

Tree -4 – Crepe Myrtle located beside the deck on the back of the house. It can be remove with the shrubs surrounding the house.

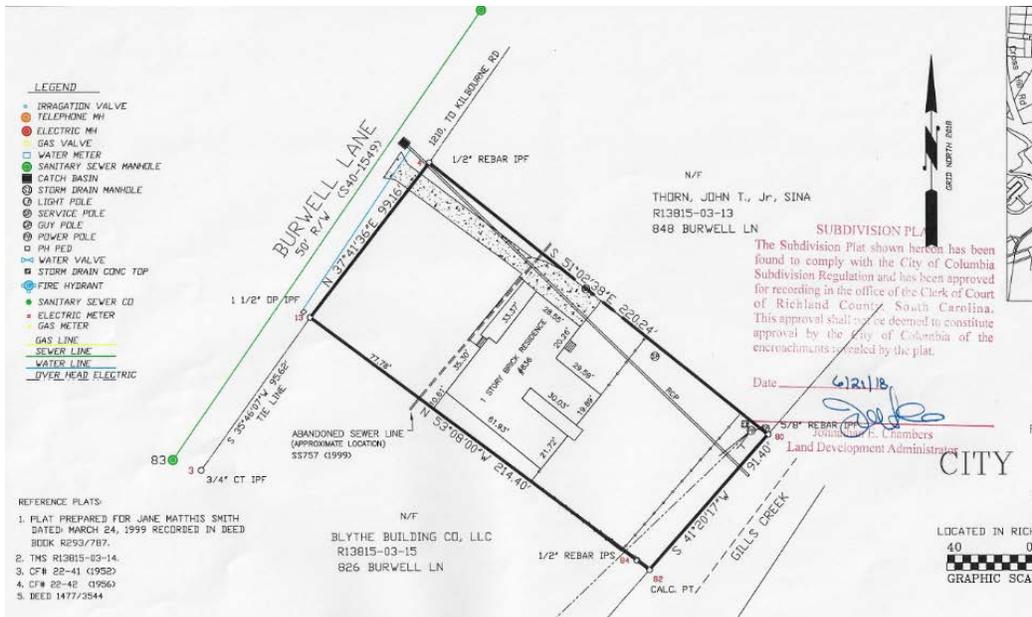
Figure 1 836 Burwell Lane

Landmark performed a field inspection of the 836 property with the ALTA survey information. The inspection was to identify possible issues associated with future plans to demolish the property. The following are specific notes and photographs.

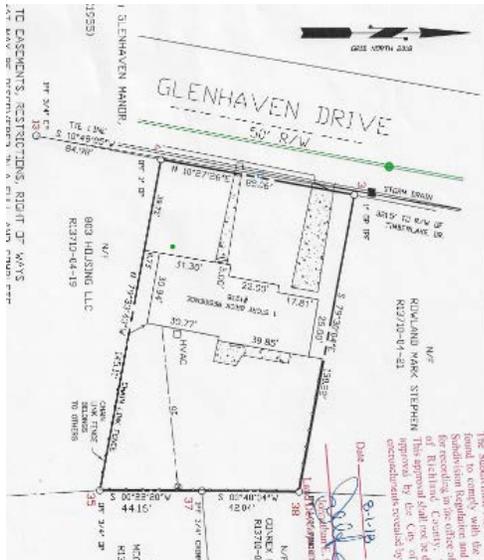
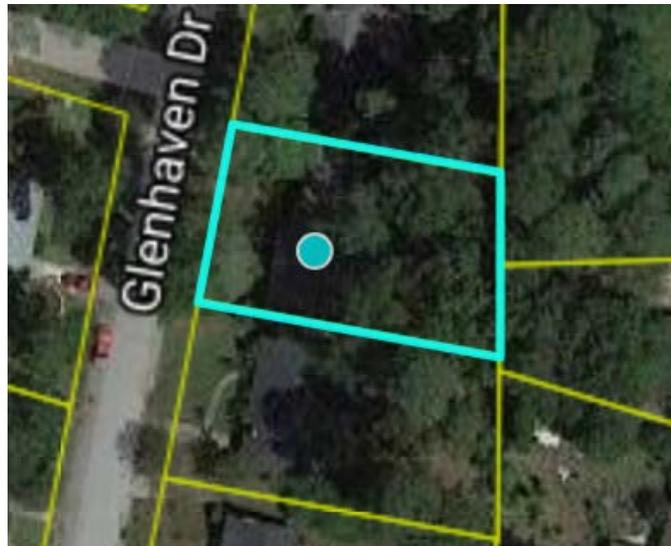
Figure 1 1238 Glenhaven Drive

Landmark performed a field inspection (8/2/2018) of the 1238 property with the ALTA survey information (Figure 1). The inspection was to identify possible issues associated with future plans to demolish the structure(s) and create green space in accordance with FEMA CDBG-DR requirements. Specific notes and photographs for identified issues are provided.

Tree 1 - Large Pine (20 to 24 inch) located at the NE corner of the property has buckled the driveway. Removal of the structure may cause potential issues with the roots under the driveway (Figure 2).
